## Test Results

### Fleet Service Medivan Testing

Medivan – A dual compartment climatic controlled pharmaceutical delivery vehicle.

MIRA's Vehicle Climatic Chambers

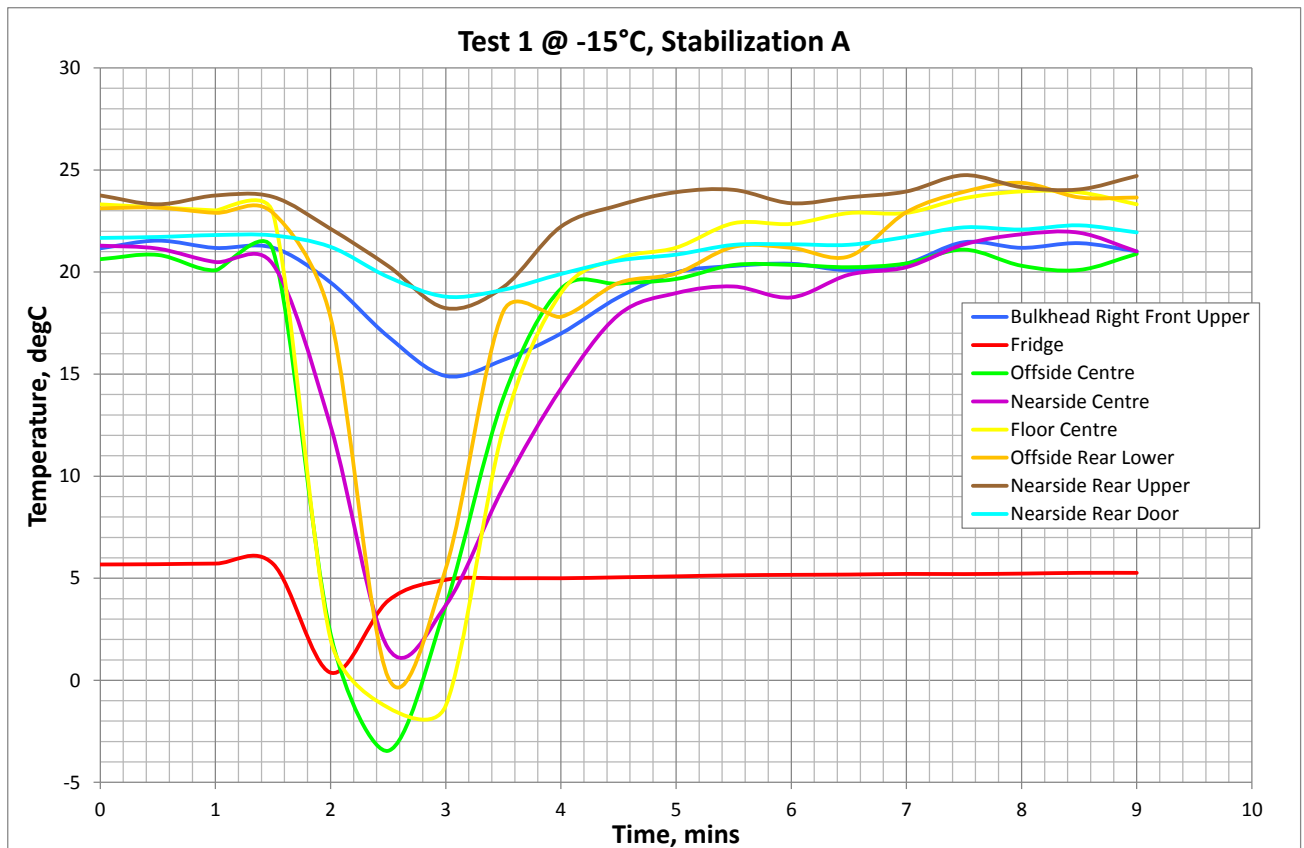
Graph 1

Three different ambient temperature conditions were used for this evaluation along with 7 stabilization periods used in total. The ambient temperatures used were -15°C, 0°C and +30°C.

The results of each test, at each temperature, are shown in Graphs 1 to 14

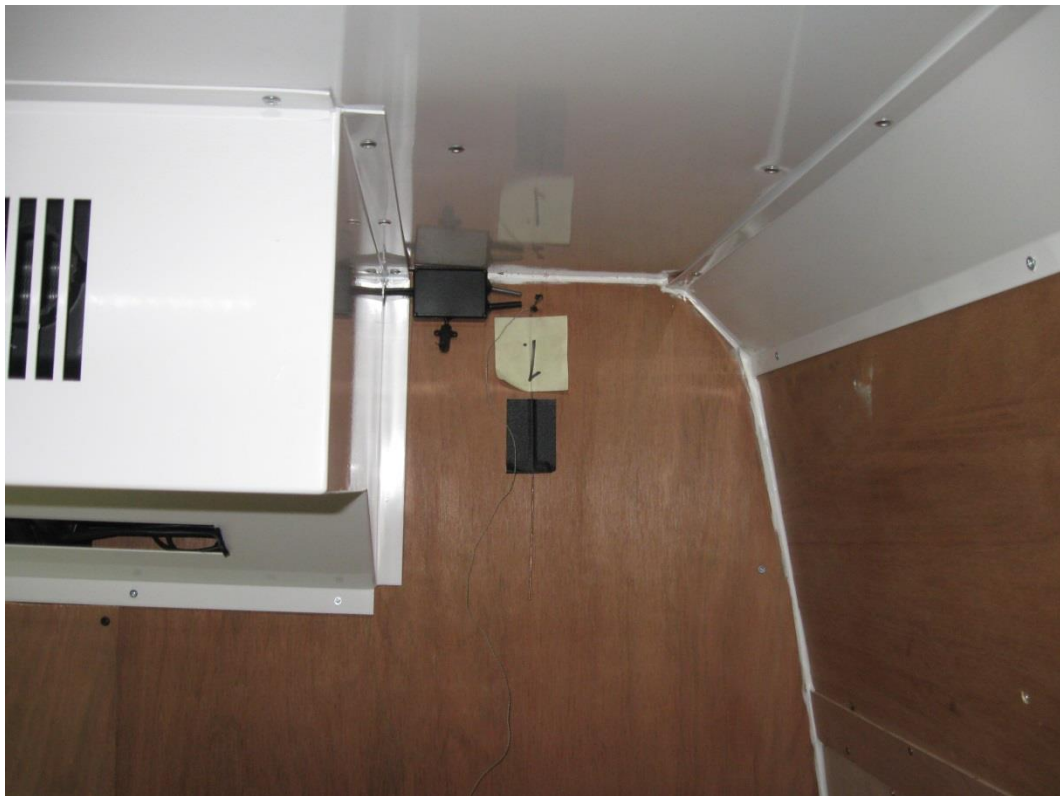
**Photo 3**

The vehicle was fitted with 8 thermocouples:

Each location is shown in Photos 3 to 10
